Figure A-2
Site-Wide Soil Sampling Results for
Soil Alternatives: Copper
Riverside Industrial Park Superfund Site
Essex County, New Jersey

Riverside Industrial Park Superfund Site

Essex County, New Jersey

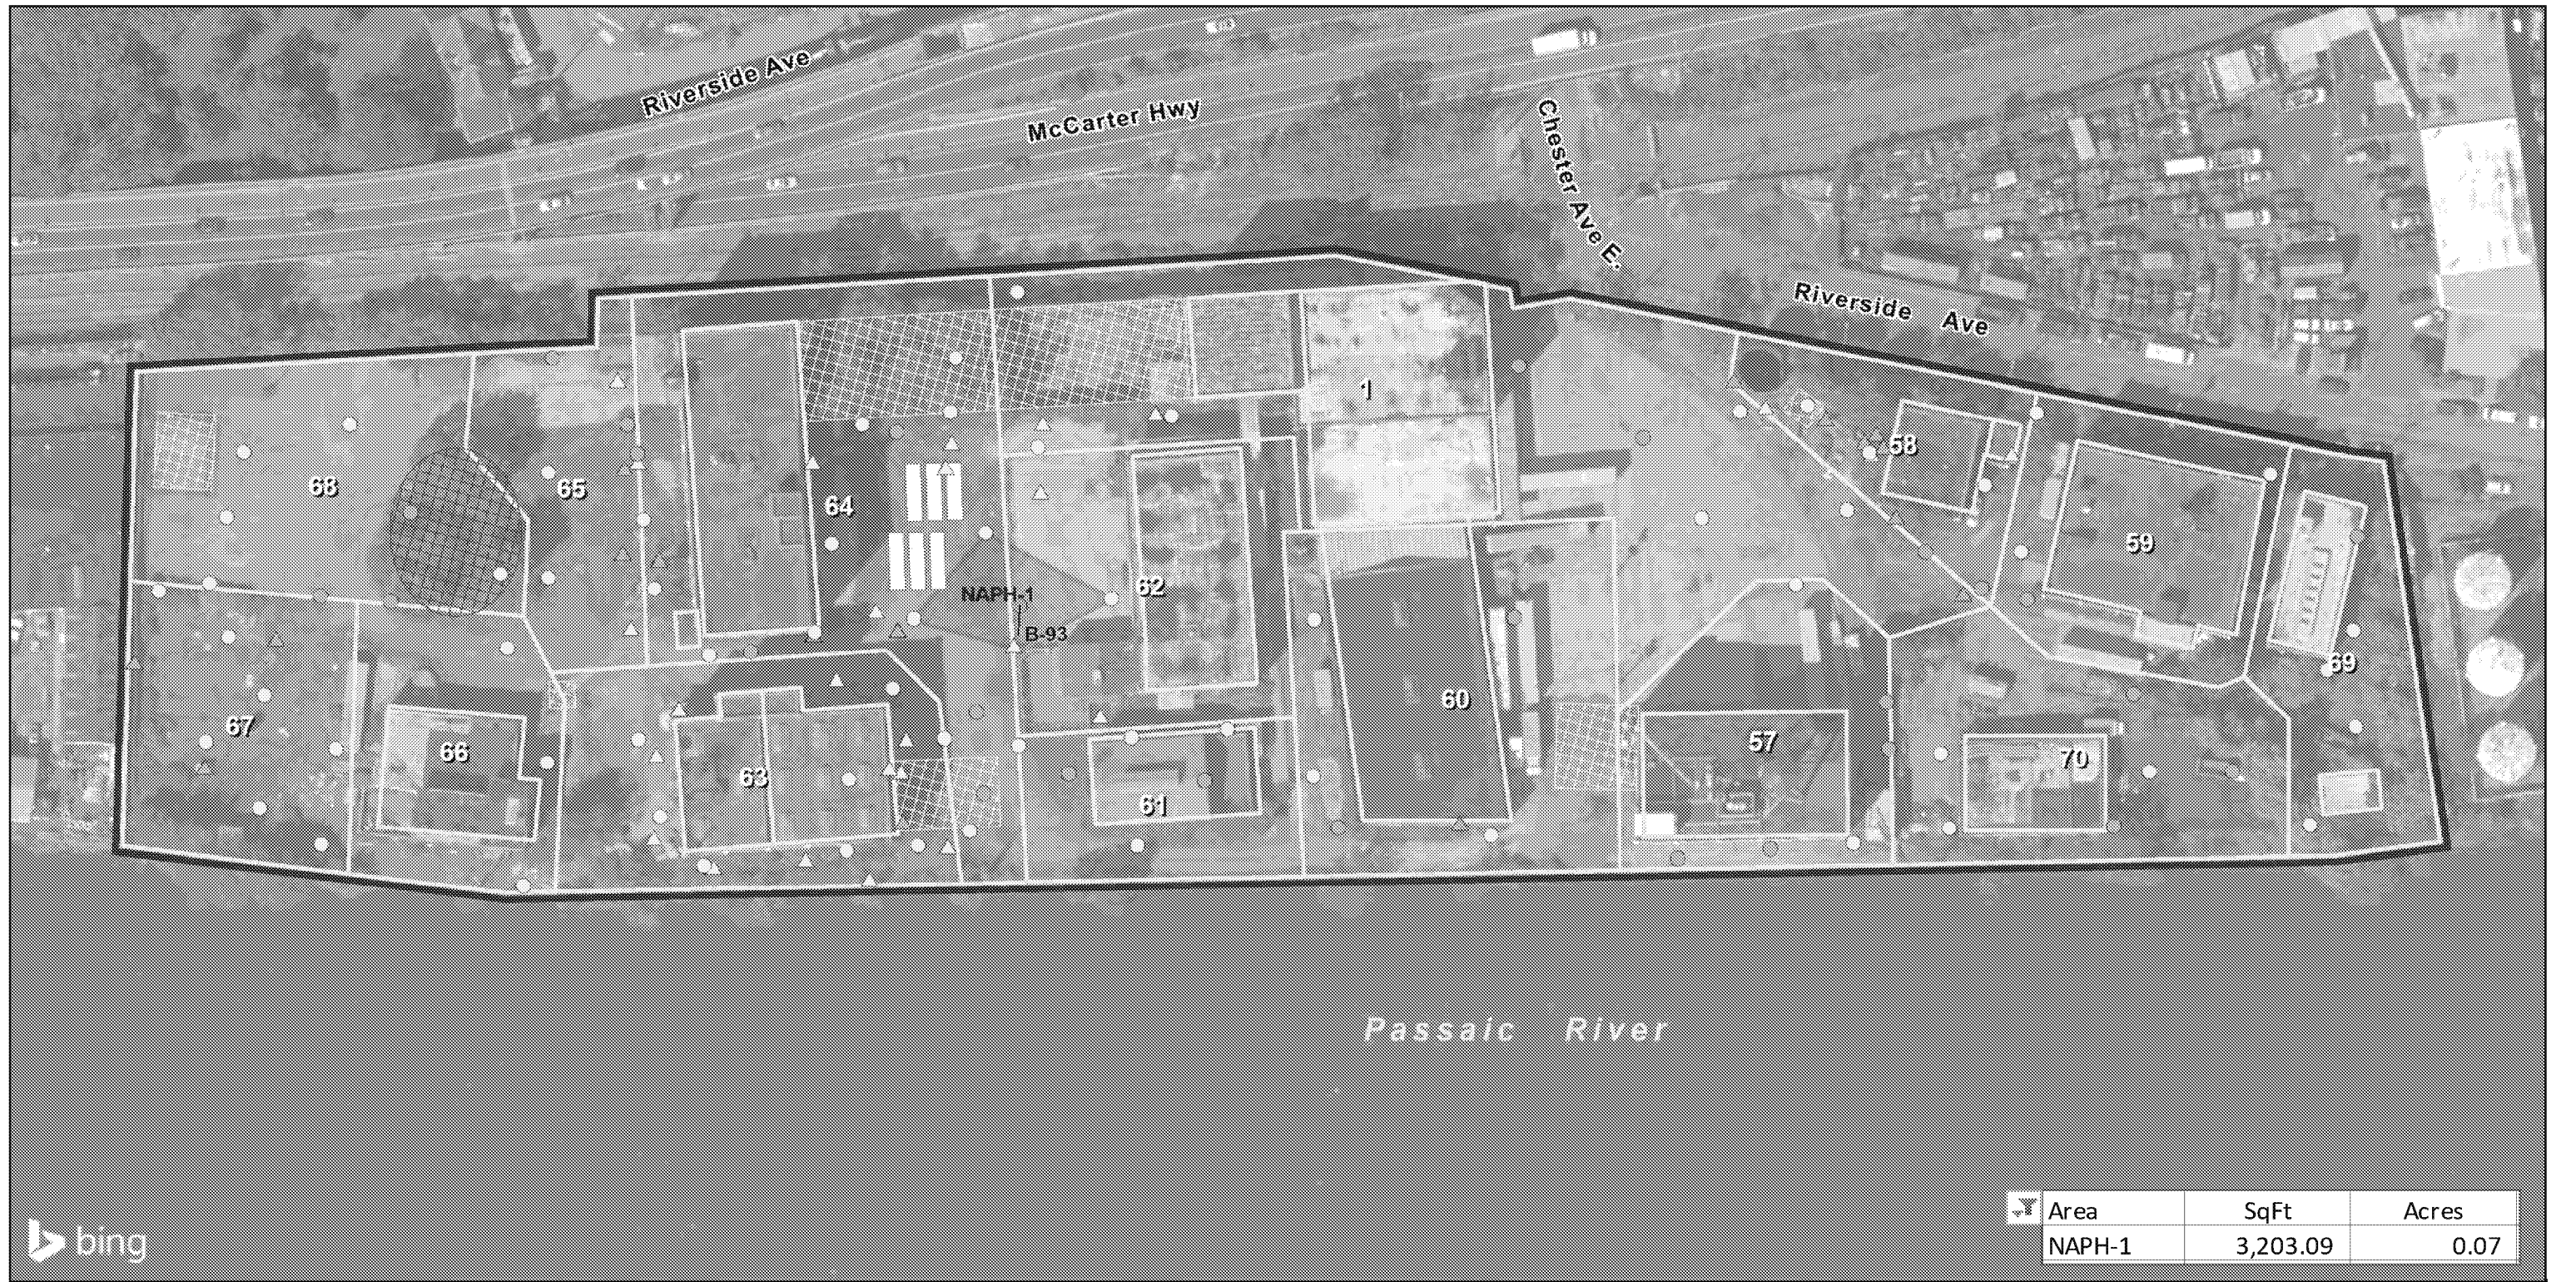
Area	SqFt	Acres
NAPH-1	3,203.09	0.07

Figure A-10
Site-Wide Sampling Results for
Soil Alternatives: Naphthalene
Riverside Industrial Park Superfund Site
Essex County, New Jersey

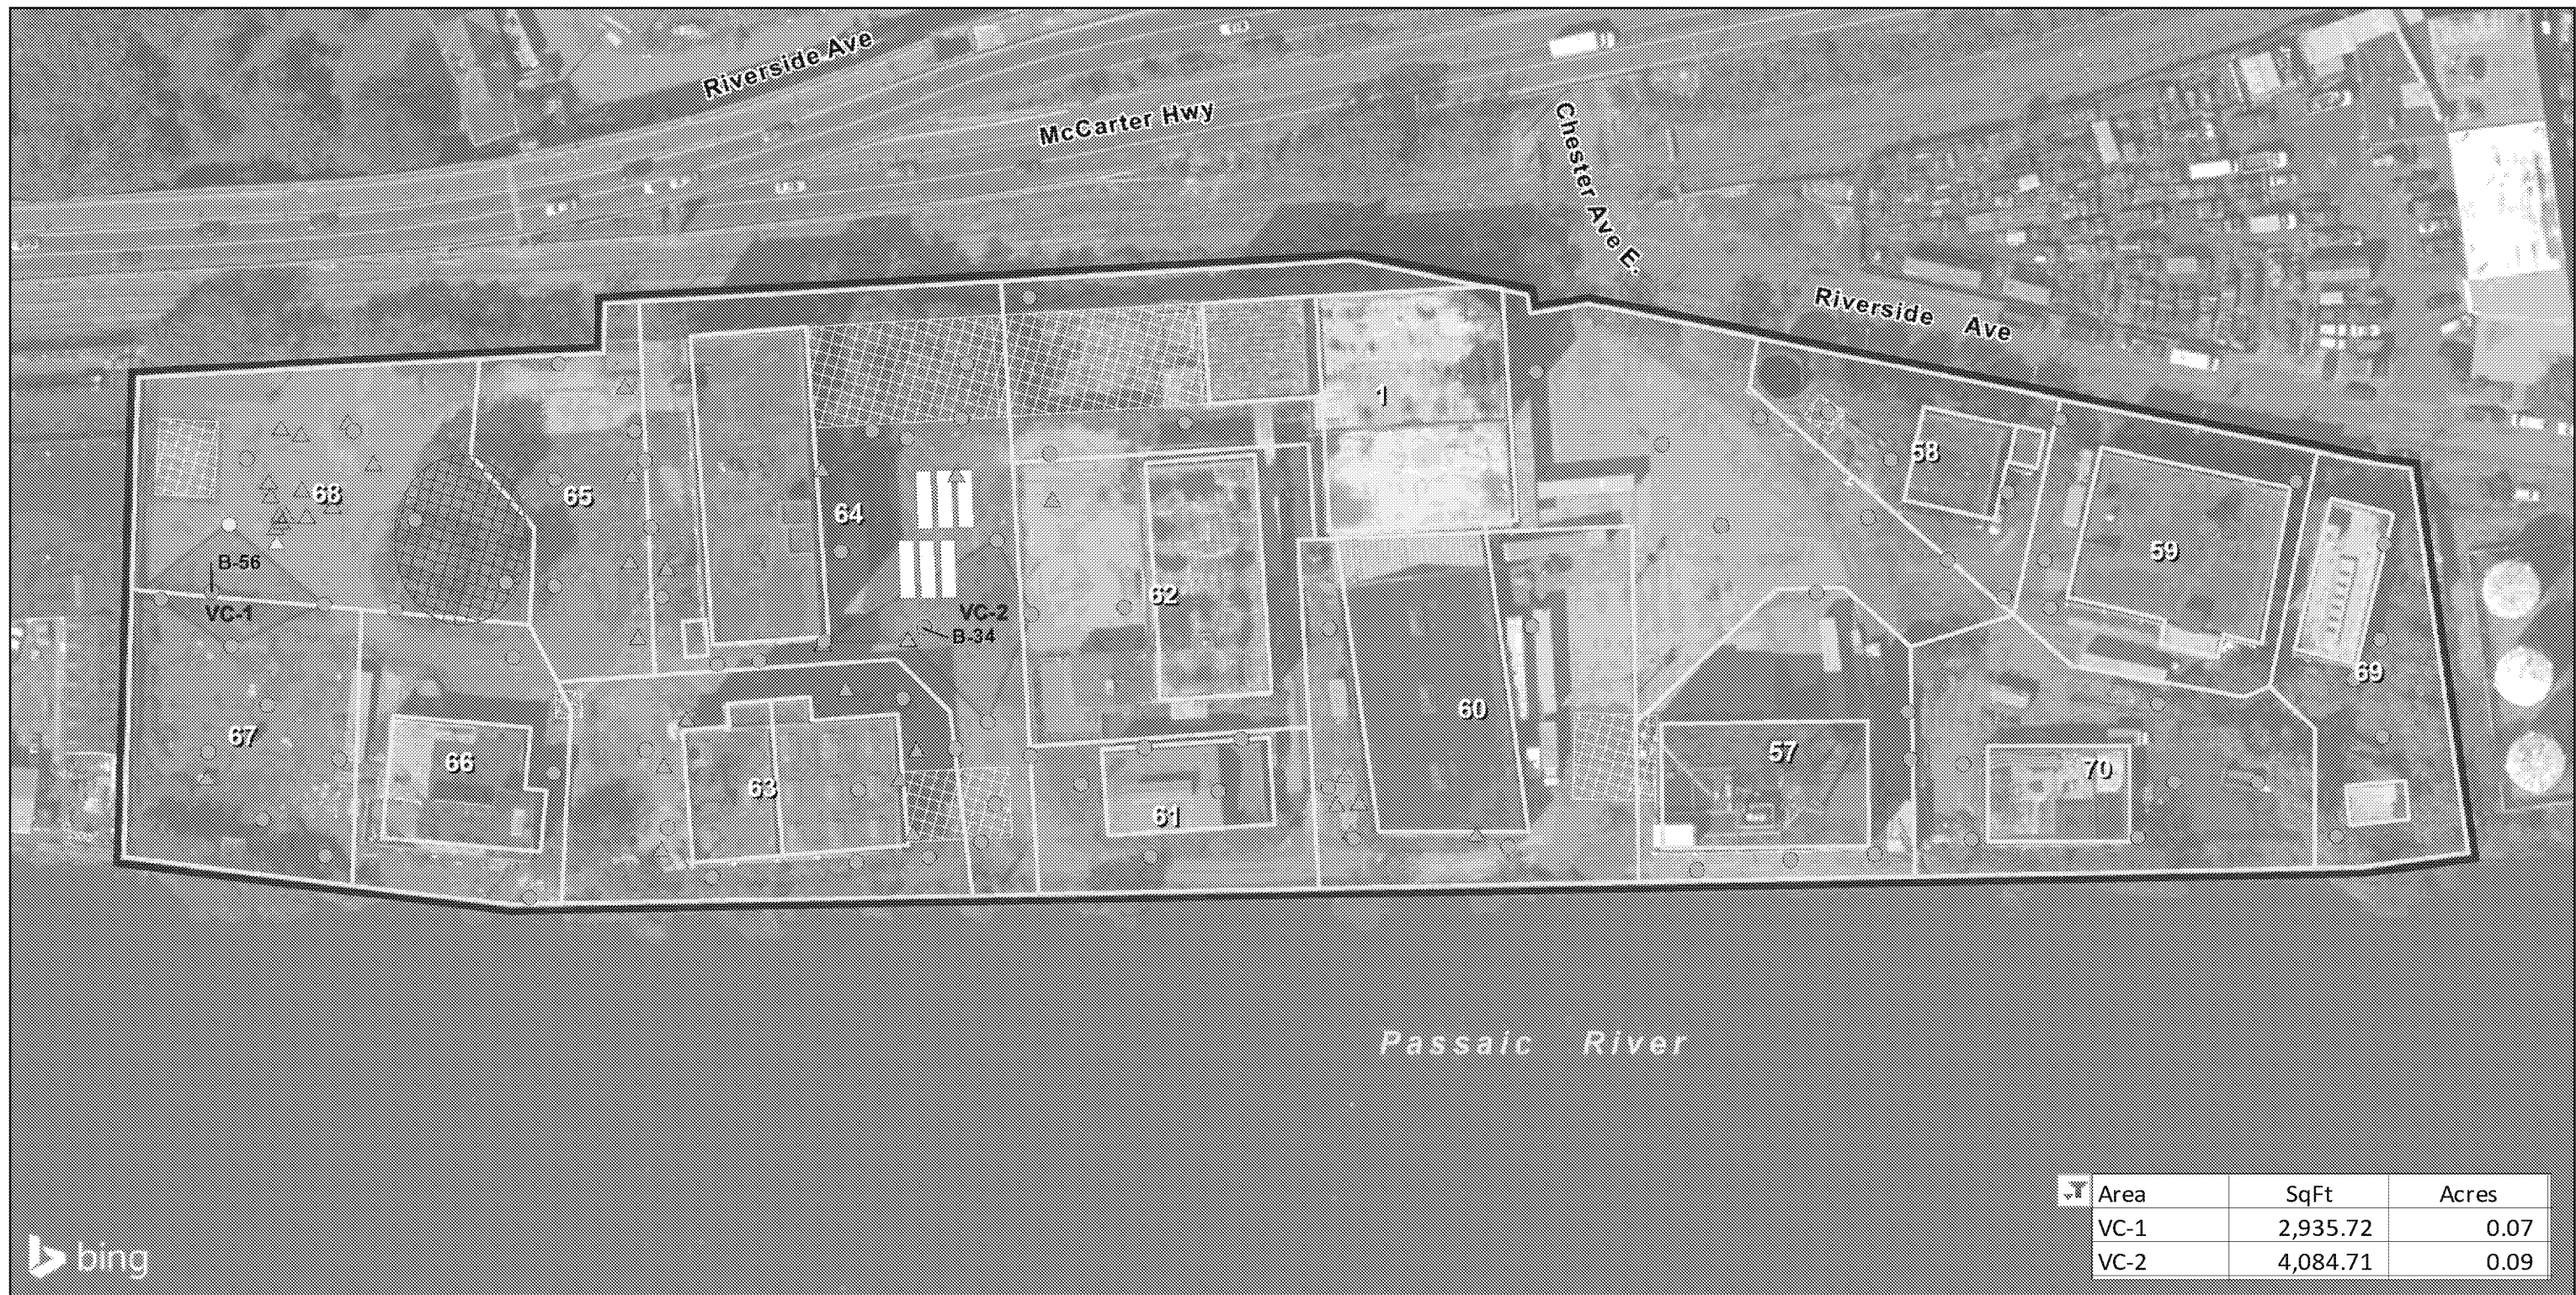
Figure A-11
Site-Wide Sampling Results for
Soil Alternatives: Vinyl Chloride
Riverside Industrial Park Superfund Site
Essex County, New Jersey
